**Flood Control Project Maintenance
Levee Inspections**

Fall 2018 Levee Maintenance Deficiency Summary Report

Sacramento River Basin

Reclamation District No. 0070 Meridian

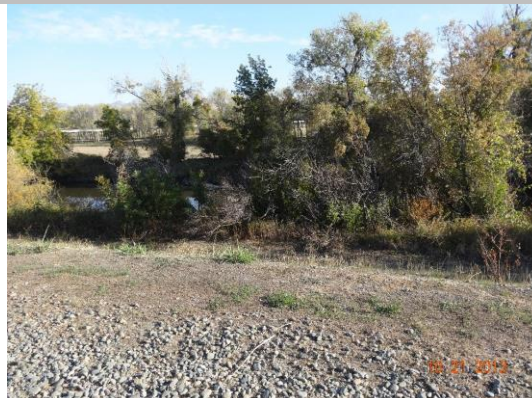
Photo 1 of 3 : UCIP_FA_2018_23463_40622.jpg

Comment Code					
Inspector Comment					
FS_ID:23463 DS_ID:21347 EP_NO: 3804 Repair Type: Non-Urgent Crossing Status: Indicator Found UCIP Comments: Unable to confirm if the indicators that were found in the field correspond to this crossing. Will need to contact PG&E to confirm location of crossing. Photos will need to be updated if the photos attach do not correspond to this crossing. This crossing is referenced in the USACE Periodic Inspection as item USACE_CESPK_MRD1_2012_p_0304 for 12 inch gas pipe. Coordinates between DWR UCIP and USACE PI are approximately 630 feet apart. FIELD_STRUCT_DESC: 12-inch coated steel natural gas pipeline through the levee, 3.6 feet below the crown. Concrete cutoff wall around the pipe at the center of the levee. Marker sign on the waterside (WS) shoulder. Rock revetment on the WS slope. (Plans for installation of a 12-inch gas collecting line through the levee authorized under Permit No. 3804, 1961 - Pacific Gas and Electric Company [PG&E]). [Additional Reference(s): DWR Levee Log, 2007]. FS Date: 10/21/2013

View of waterward side--no markers visible.

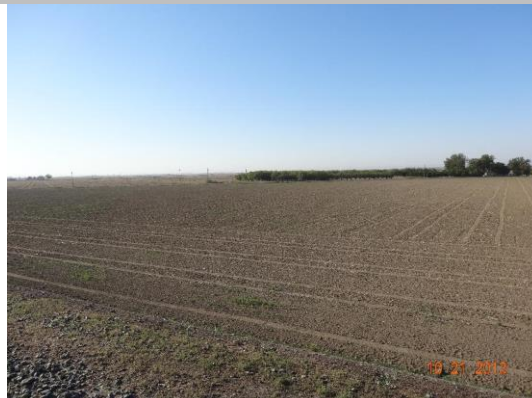
Photo 2 of 3 : UCIP_FA_2018_23463_40621.jpg

View of landward side where gas line markers are visible approximately 900 feet from levee.

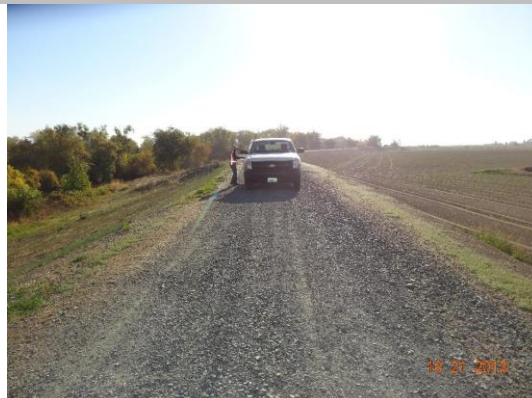
Photo 1 of 3 : UCIP_FA_2018_23503_40784.jpg

Comment Code						
Inspector Comment						
FS_ID:23503 DS_ID:21351 EP_NO: 3686 Repair Type: Non-Urgent Crossing Status: Found UCIP Comments: Dense vegetation limits the inspector's visibility to identify signs of pipe failure (leaks) along the waterward slope. Recommend removing vegetation along pipe alignment to conduct proper inspection of structure and appurtenances. Unable to find the gate valve on landward side. Walkway on waterward side in bad shape. This crossing is referenced in the USACE Periodic Inspection as item USACE_CESPK_MRD1_2012_p_0300 for 18 inch pipe. Pipe on LS is 10 inch not 18 inch. SEE UCIP DS_ID 21350 for details pertaining to 18 inch pipe. FIELD_STRUCT_DESC: 10-inch irrigation discharge pipe of an unknown material through the levee, 14.8 feet below the crown. Electrical conduit through the levee, 1 foot below the crown. Pump on a pile structure in the stream. Service pole with meter and control panel at the landside (LS) toe. Slide gate with walkway on the waterside (WS) end. Gate valve on the LS end, not found during 10/21/2013 pipe inventory. Rock revetment on the WS slope. (Plans for removal of a pump on the LS and installation of a pump and two concrete piers on the WS authorized under Permit No. 3686, 1961 - Gerald A. Frye). [Additional Reference(s): DWR Levee Log, 2007]. FS Date: 10/21/2013

View of levee crown looking upstream from crossing.

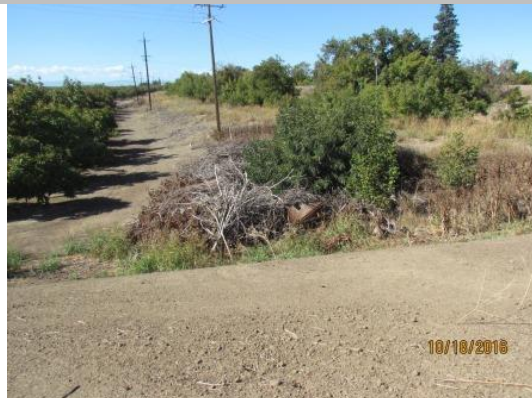
Photo 1 of 1 : FA_2018_RD0070_29_33_20180905_00009.jpg

View of the prunings along the landside toe.

LM Start	0.75	Rating **	M	Issue No.	33
LM End	0.75	Issue Type +	En	Location *	LS
Category	Earthen Levee			GPS Latitude/Longitude	
				Start	End
Item	Encroachments			39.145095 °	39.145095 °
				-121.842865 °	-121.842865 °
DWR ID	DWR_RD0070_01_f_2016_33				
Comment Code					
PR : Prunings					
Inspector Comment					
Remove the prunings from the landside slope.

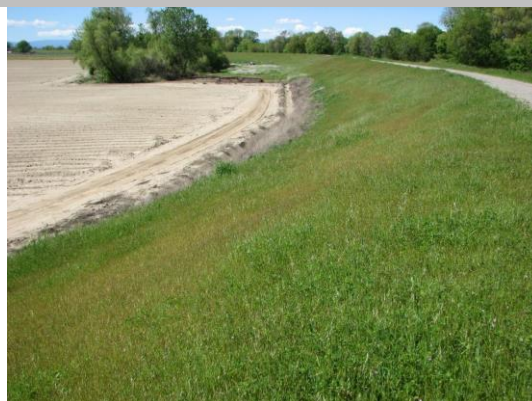
Photo 1 of 1 : FA_2018_RD0070_29_27_20180905_00003.jpg

LM Start	2.74	Rating **	M	Issue No.	27
LM End	2.82	Issue Type +	En	Location *	LS
Category	Earthen Levee			GPS Latitude/Longitude	
				Start	End
Item	Encroachments			39.157741 °	39.158135 °
				-121.871588 °	-121.872979 °
DWR ID	DWR_RD0070_01_s_2016_27				
Comment Code					
DT : Ditch					
Inspector Comment

Concrete ditch at landside toe.

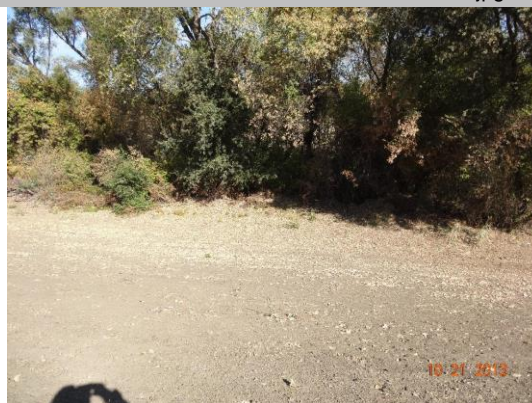
Photo 1 of 3 : UCIP_FA_2018_23530_40968.jpg

Comment Code					
Inspector Comment					
FS_ID:23530 DS_ID:21322 EP_NO: N/A Repair Type: Non-Urgent Crossing Status: Indicator Found UCIP Comments: Unable to determine if crossing exists need to coordinate with LMA to determine if more information is available about crossing. This crossing is referenced in the USACE Periodic Inspection as item USACE_CESPK_MRD1_2012_p_0208 for concrete ditch lined within 15 feet of LS toe, no water present, and no USACE recommendation letter available. FIELD_STRUCT_DESC: 12-inch steel irrigation discharge pipe through the levee, at an unknown depth. Cutoff wall around the pipe at the center of the levee. Slide gate on each end. Pump on the waterside (WS). Concrete distribution box on the landside (LS). [Additional Reference(s): USACE Sacramento O&M Manual 134, June 1953, (Station 142+70)]. FS Date: 10/21/2013

View of waterward side.

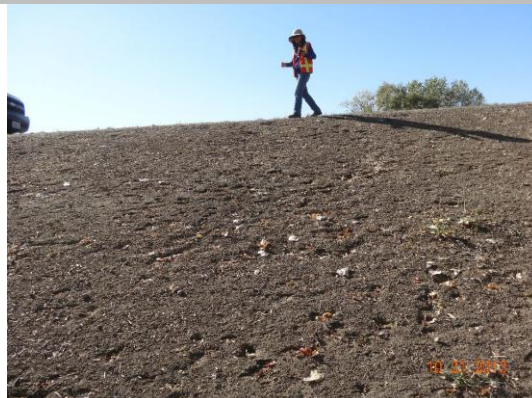
Photo 2 of 3 : UCIP_FA_2018_23530_40972.jpg

View of waterward slope.

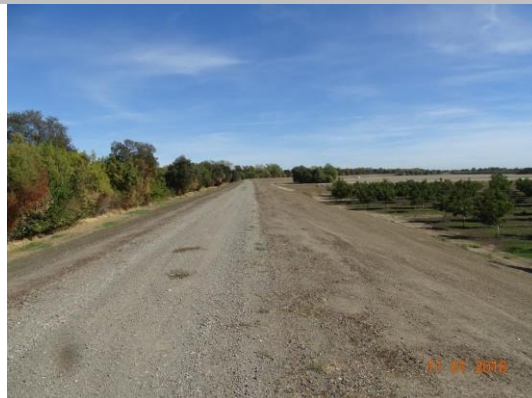
Photo 1 of 1 : FA_2018_RD0070_29_31_20181102_00073.jpg

LM Start	3.14	Rating **	A	Issue No.	31
LM End	3.14	Issue Type +	Ma	Location *	LS
Category	Earthen Levee			GPS Latitude/Longitude	
				Start	End
Item	Vegetation			39.158102°	39.158102°
				-121.879027°	-121.879027°
DWR ID	DWR_RD0070_01_f_2018_31				
Comment Code					
V1 : Control annual grass and weeds on the levee slopes and easements.					
Inspector Comment					
There is no vegetation on both slopes.

View of no vegetation on both slopes.

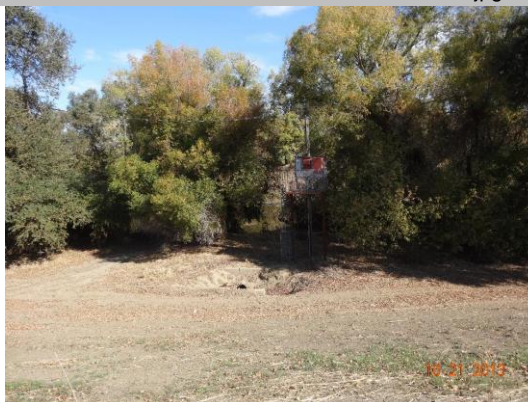
Photo 2 of 3 : UCIP_FA_2018_23510_40838.jpg

View of waterward side.

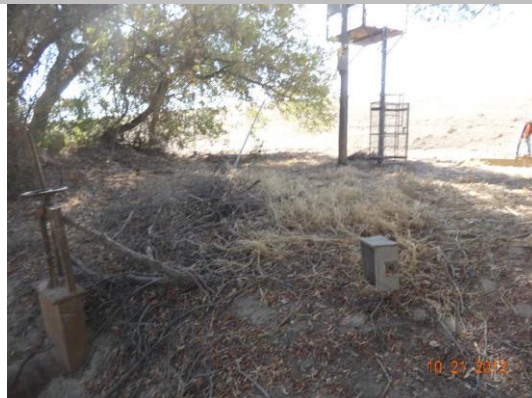
Photo 3 of 3 : UCIP_FA_2018_23510_40836.jpg

View of appurtenances located on waterward side.

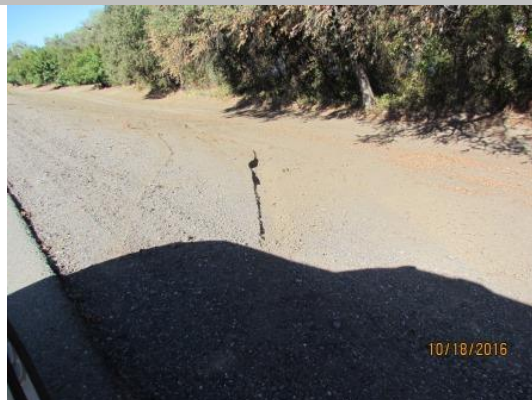
Photo 1 of 1 : FA_2018_RD0070_29_29_20180905_00005.jpg

View of the ruts along the waterside slope.

LM Start	3.72	Rating **	M	Issue No.	29
LM End	3.72	Issue Type +	Ma	Location *	WS
Category	Earthen Levee			GPS Latitude/Longitude	
				Start	End
Item	Slope Stability			39.158183 °	39.158183 °
				-121.888397 °	-121.888397 °
DWR ID	DWR_RD0070_01_f_2016_29				
Comment Code					
S3 : Repair the levee slope damaged by vehicle traffic and prevent access where possible.					
Inspector Comment

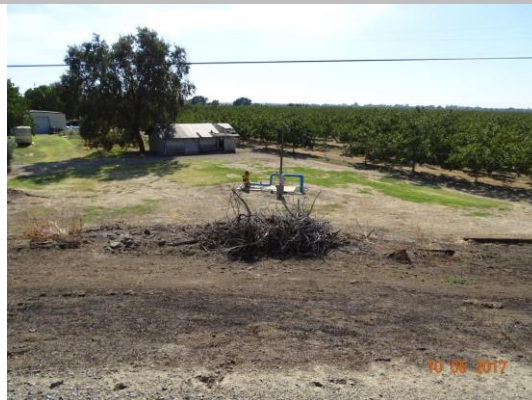
Photo 1 of 1 : FA_2018_RD0070_29_39_20180905_00018.jpg

View of the prunings along the landside toe.

LM Start	4.15	Rating **	M	Issue No.	39
LM End	4.15	Issue Type +	En	Location *	LS
Category	Earthen Levee			GPS Latitude/Longitude	
				Start	End
Item	Encroachments			39.162757 °	39.162757 °
				-121.893805 °	-121.893805 °
DWR ID	DWR_RD0070_01_f_2017_39				
Comment Code					
PR : Prunings					
Inspector Comment					
Remove the prunings from the landside toe.

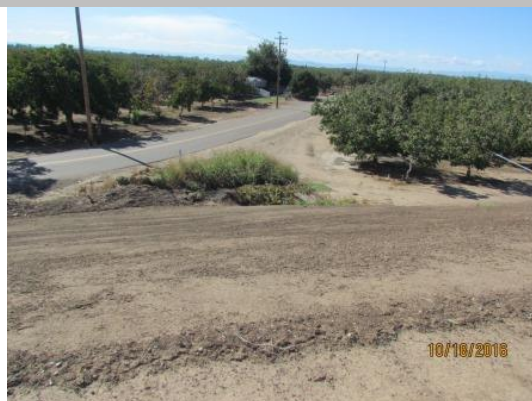
Photo 2 of 2 : FA_2018_RD0070_29_30_20180905_00007.jpg

View of the prunings along the landside toe.

LM Start	4.65	Rating **	M	Issue No.	30 (cont)	
LM End	4.65	Issue Type +	En	Location *	LS	
Category	Earthen Levee			GPS Latitude/Longitude		
				Start		End
Item	Encroachments			39.168110 °		39.168110 °
				-121.899910 °		-121.899910 °
DWR ID	DWR_RD0070_01_f_2016_30					
Comment Code						
PR : Prunings						
Inspector Comment						
Remove the prunings from the landside slope.

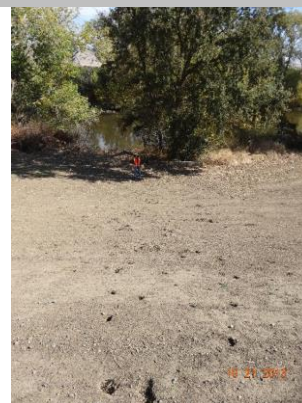
Photo 1 of 3 : UCIP_FA_2018_23517_40883.jpg

Comment Code						
Inspector Comment						
FS_ID:23517 DS_ID:21340 EP_NO: 9954 Repair Type: Non-Urgent Crossing Status: Found UCIP Comments: Burrow activity present on waterward slope. Need to coordinate with owner to determine status of crossing. If crossing is no longer in use owner will need to contact the CVFPB to comply with Title 23. This crossing is referenced in the USACE Periodic Inspection as item USACE_CESPK_MRD1_2012_p_0134. FIELD_STRUCT_DESC: 24-inch corrugated metal irrigation discharge pipe through the levee, 19 feet below the crown. Slide gate on the waterside (WS). Concrete distribution box at the landside (LS) toe. (Retention of a 24-inch corrugated metal pipe (CMP) through the levee, 19 feet below the crown, a slide gate, and a concrete distribution box authorized under Automatic Board Order (ABO) issued as Permit No. 9954, 1974 - Parker A. Reische). [Additional Reference(s): DWR Levee Log, 2007]. FS Date: 10/21/2013

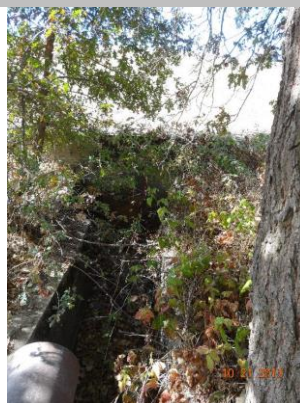
Photo 2 of 3 : UCIP_FA_2018_23517_40877.jpg

Comment Code						
Inspector Comment						
FS_ID:23517 DS_ID:21340 EP_NO: 9954 Repair Type: Non-Urgent Crossing Status: Found UCIP Comments: Burrow activity present on waterward slope. Need to coordinate with owner to determine status of crossing. If crossing is no longer in use owner will need to contact the CVFPB to comply with Title 23. This crossing is referenced in the USACE Periodic Inspection as item USACE_CESPK_MRD1_2012_p_0134. FIELD_STRUCT_DESC: 24-inch corrugated metal irrigation discharge pipe through the levee, 19 feet below the crown. Slide gate on the waterside (WS). Concrete distribution box at the landside (LS) toe. (Retention of a 24-inch corrugated metal pipe (CMP) through the levee, 19 feet below the crown, a slide gate, and a concrete distribution box authorized under Automatic Board Order (ABO) issued as Permit No. 9954, 1974 - Parker A. Reische). [Additional Reference(s): DWR Levee Log, 2007]. FS Date: 10/21/2013

View of pipe located on waterward side.

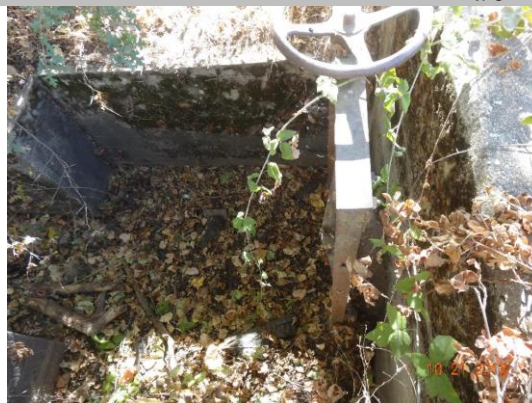
Photo 3 of 3 : UCIP_FA_2018_23517_40882.jpg

View of slide gate on waterward side.

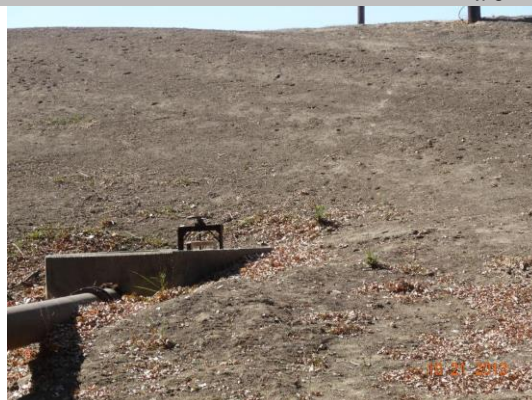
Photo 2 of 3 : UCIP_FA_2018_23518_40887.jpg

View of waterward slope.

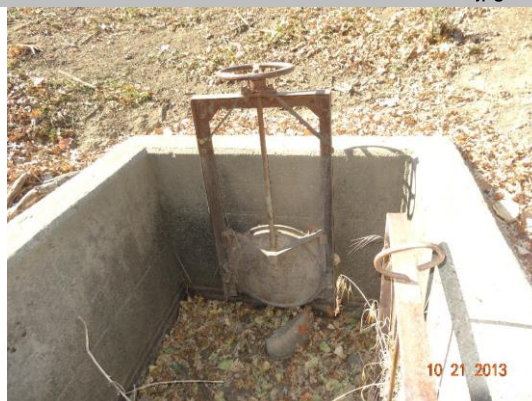
Photo 3 of 3 : UCIP_FA_2018_23518_40890.jpg

Comment Code						
Inspector Comment						
FS_ID:23518 DS_ID:21338 EP_NO: 9940 Repair Type: Non-Urgent Crossing Status: Found UCIP Comments: No connection present--need to contact owner to determine if owner plans to use. If crossing is no longer in use owner will need to coordinate with DWR inspector and CVFPB to remove according to Title 23 requirements. Unable to determine if crossing is in use. This crossing is referenced in the USACE Periodic Inspection as item USACE_CESPK_MRD1_2012_p_0125. FIELD_STRUCT_DESC: 18-inch steel irrigation discharge pipe through the levee, 19 feet below the crown. Cutoff wall around the pipe at the center of the levee. Slide gate in a concrete distribution box on the landside (LS). Pump on the waterside (WS). Pipe discharges into a concrete box on the LS. (Retention of an 18-inch steel pipe through the levee, 19 feet below the crown, a pump, a slide gate in a concrete distribution box, and a concrete box authorized under Automatic Board Order (ABO) issued as Permit No. 9940, 1974 - Pearl Clark, et al.). [Additional Reference(s): DWR Levee Log, 2007. USACE Sacramento O&M Manual 134, June 1953, (Station 251+30)]. FS Date: 10/21/2013

Screw gate located inside concrete distribution box located on waterward side.

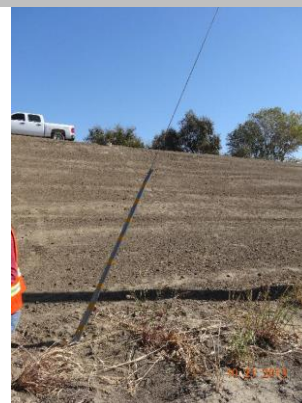
Photo 3 of 3 : UCIP_FA_2018_23519_40897.jpg

Comment Code						
Inspector Comment						
FS_ID:23519 DS_ID:21357 EP_NO: 9957 Repair Type: Non-Urgent Crossing Status: Found UCIP Comments: Burrow activity on slopes -- recommend addressing issue. This crossing is referenced in the USACE Periodic Inspection as item USACE_CESPK_MRD1_2012_p_0110. FIELD_STRUCT_DESC: 12-inch steel irrigation discharge pipe through the levee, 5.5 feet below the crown. Pump on the waterside (WS) slope. Siphon breaker in a corrugated metal pipe (CMP) riser on the landside (LS) slope. Pipe discharges into a concrete box at the LS toe. Service pole at the LS toe. (Plans to retain a 12-inch steel pipe through the levee, 5.5 feet below the crown, a siphon breaker in a CMP riser, a pump, and a concrete box authorized under Automatic Board Order (ABO) issued as Permit No. 9957, 1974 - James E. and Mattie Smith). [Additional Reference(s): DWR Levee Log, 2007]. FS Date: 10/21/2013

View of landward slope.

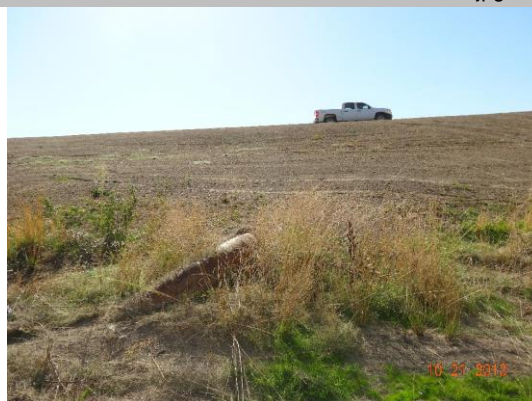
Photo 3 of 3 : UCIP_FA_2018_46422_40913.jpg

Comment Code						
Inspector Comment						
FS_ID:46422 DS_ID:21341 EP_NO: 9960 Repair Type: Non-Urgent Crossing Status: Found UCIP Comments: 07/28/2015 Pipe appears still appears abandoned. Priority was downgraded from Urgent to Non-Urgent due to the inactivity. Need to contact owner to confirm status and future use. If crossing is no longer in use owner will need to coordinate with DWR inspector and CVFPB to remove according to Title 23 requirements.10/21/2013 Hole present on pipe on waterward side. This crossing was determined urgent due to hole on pipe-no signs leaks present on waterward or landward slopes. Unable to find if crossing is being used. Need to contact owner to determine crossing is still in use. If crossing is no longer in use owner will need to coordinate with DWR inspector and CVFPB to remove according to Title 23 requirements. Unable to determine if crossing is in use. This crossing is referenced in the USACE Periodic Inspection as item USACE_CESPK_MRD1_2012_p_0069. FIELD_STRUCT_DESC: 12-inch steel pipe of an unknown purpose through the levee, 6.2 feet below the crown. Siphon breaker in a corrugated metal pipe (CMP) riser on the landside (LS) slope. Service pole on the LS shoulder. Concrete distribution box at the LS toe. (Retention of a 12-inch steel pipe through the levee, 6.2 feet below the crown, a siphon breaker in a CMP riser, a service pole, and a concrete distribution box authorized under Automatic Board Order (ABO) issued as Permit No. 9960, 1974 - Richard L. and Mildred E. Tarke). [Additional Reference(s): DWR Levee Log, 2007. USACE Sacramento O&M Manual 134, June 1953, (Station 332+72)]. FS Date: 7/28/2015 3:30:00 PM

View of waterward slope and pipe at levee toe.

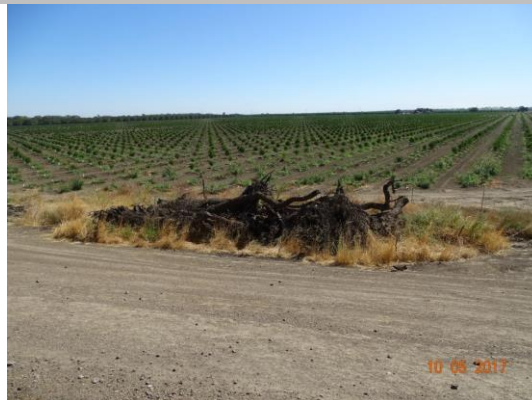
Photo 1 of 1 : FA_2018_RD0070_29_38_20180905_00017.jpg

View of the tree limbs along the landside toe.

LM Start	7.54	Rating **	M	Issue No.	38
LM End	7.54	Issue Type +	En	Location *	LS
Category	Earthen Levee			GPS Latitude/Longitude	
				Start	End
Item	Encroachments			39.196665 °	39.196665 °
				-121.929558 °	-121.929558 °
DWR ID	DWR_RD0070_01_f_2017_38				
Comment Code					
TR : Tree or limb					
Inspector Comment					
Remove the tree limbs from the landside toe.

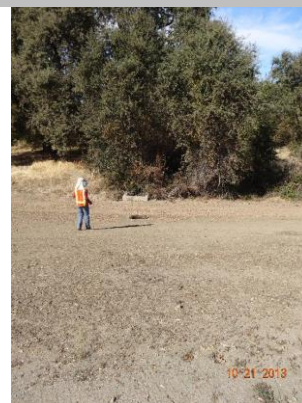
Photo 1 of 3 : UCIP_FA_2018_23529_40964.jpg

Comment Code						
Inspector Comment						
FS_ID:23529 DS_ID:21345 EP_NO: 9942 Repair Type: Non-Urgent Crossing Status: Found UCIP Comments: Dense vegetation limits the inspector's visibility to identify signs of pipe failure (leaks) along the slope. Recommend removing vegetation along pipe alignment to conduct proper inspection of structure and appurtenances. This crossing is referenced in the USACE Periodic Inspection as item USACE_CESPK_MRD1_2012_p_0005. FIELD_STRUCT_DESC: 24-inch corrugated metal irrigation discharge pipe through the levee, 16.5 feet below the crown. Incline pump on the waterside (WS). Slide gate in a corrugated metal pipe (CMP) riser on the WS slope. Pipe discharges into a concrete box at the landside (LS) toe. Service pole on the LS. (Retention of a 24-inch CMP through the levee, 16.5 feet below the crown, a slant pump, a slide gate in a CMP riser, a box, and a service pole authorized under Automatic Board Order (ABO) issued as Permit No. 9942, 1974 - R. W. and H. Evelyn Draper). [Additional Reference(s): DWR Levee Log, 2007. USACE Sacramento O&M Manual 134, June 1953, (Station 330+00)]. FS Date: 10/21/2013

View of waterward slope.

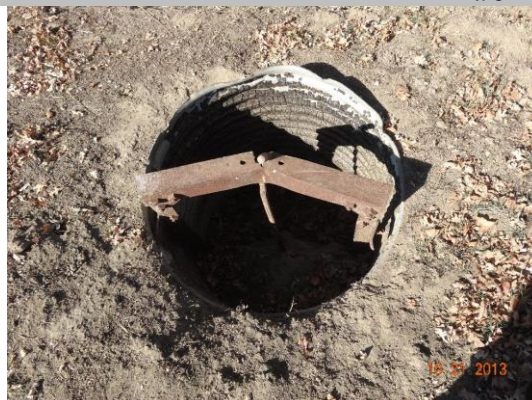
Photo 3 of 3 : UCIP_FA_2018_23529_40962.jpg

Comment Code						
Inspector Comment						
FS_ID:23529 DS_ID:21345 EP_NO: 9942 Repair Type: Non-Urgent Crossing Status: Found UCIP Comments: Dense vegetation limits the inspector's visibility to identify signs of pipe failure (leaks) along the slope. Recommend removing vegetation along pipe alignment to conduct proper inspection of structure and appurtenances. This crossing is referenced in the USACE Periodic Inspection as item USACE_CESPK_MRD1_2012_p_0005. FIELD_STRUCT_DESC: 24-inch corrugated metal irrigation discharge pipe through the levee, 16.5 feet below the crown. Incline pump on the waterside (WS). Slide gate in a corrugated metal pipe (CMP) riser on the WS slope. Pipe discharges into a concrete box at the landside (LS) toe. Service pole on the LS. (Retention of a 24-inch CMP through the levee, 16.5 feet below the crown, a slant pump, a slide gate in a CMP riser, a box, and a service pole authorized under Automatic Board Order (ABO) issued as Permit No. 9942, 1974 - R. W. and H. Evelyn Draper). [Additional Reference(s): DWR Levee Log, 2007. USACE Sacramento O&M Manual 134, June 1953, (Station 330+00)]. FS Date: 10/21/2013

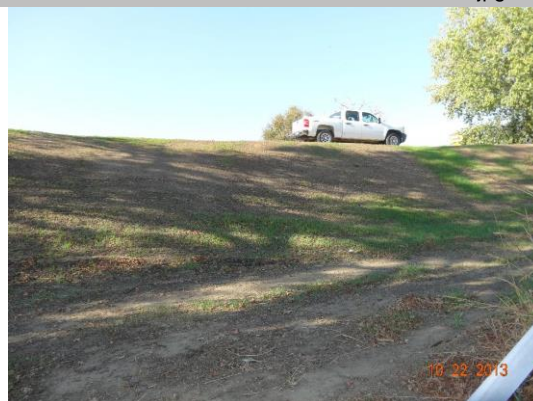
Photo 3 of 3 : UCIP_FA_2018_52618_42062.jpg

Comment Code						
Inspector Comment						
FS_ID:52618 DS_ID:21382 EP_NO: 12707 Repair Type: Urgent Crossing Status: Found UCIP Comments: 05/16/2018 2-foot round depression on waterward side found 4.5' from levee crown (Marty Rd). 14'x8'x3' excavation found on waterside slope to expose 14"-pipe. Evidence of internal erosion found at the bottom of excavation toward the pump. Cracks in asphalt pavement found on levee crown. (DWR UCIP - O.Yakimov) 11/03/2017 Crossing failed on WS and section of the levee was exposed to determine the extend of pipe damage by owner. Pipe is an up and over crossing. Crossing has been upgraded from Non-Urgent to Urgent due to pipe failure and exposed section of the levee visible on WS. (DWR UCIP - O. Magana)10/22/2013 Burrow activity noticed at this location. Crossing appurtenances have been modified. No 36-inch concrete distribution stand pipe present instead there is a concrete distribution box located at the landward toe. Also siphon breaker housing unit damage. Will need to contact owner. Need to obtain maintenance records and clarify modifications made at to crossing. Recommend having owner clear vegetation on waterward side. This crossing is referenced in the USACE Periodic Inspection as item USACE_CESPK_MRD2_2012_p_0018. FIELD_STRUCT_DESC: 14-inch coated steel irrigation discharge pipe through the levee, 3 feet below the crown. Steel cutoff wall around the pipe at the center of the levee. Pump on a metal platform (not timber as noted in the desk study) on the waterside (WS). Siphon breaker on the apex of the pipe at the WS shoulder. 36-inch concrete standpipe at the landside (LS) toe, not found during October 2013 inspection. Service pole at the LS toe. Rock revetment on the WS slope. (Plans to install a 30-kilowatt [40-horsepower] pump on the riverbank with a 14-inch steel discharge pipe through the levee authorized under Permit No. 12707, 1979 - Roger C. Wilber, Butte Creek Farms). [Additional Reference(s): DWR Levee Log, 2007]. FS Date: 5/16/2018

View of levee slope on landward side.

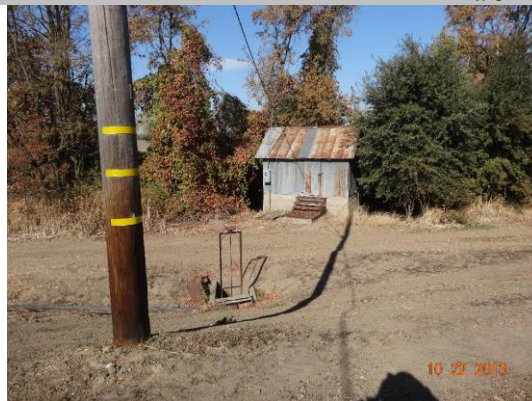
Photo 1 of 3 : UCIP_FA_2018_42923_42036.jpg

Comment Code						
Inspector Comment						
FS_ID:42923						
DS_ID:21412						
EP_NO: 1575						
Repair Type: Non-Urgent						
Crossing Status: Found						
UCIP Comments: Debris scattered on waterward side. Concrete structure on waterward side shows major cracks on the walls. Will need to notify owner. Need to obtain maintenance records to confirm integrity of pipe. This crossing is referenced in the USACE Periodic Inspection as item USACE_CESPK_MRD2_2012_p_0075.						
FIELD_STRUCT_DESC: 20-inch steel irrigation discharge pipe through the levee, 17 feet below the crown. Pump and 10-inch slide gate in a pump house on the waterside (WS). Concrete collar at the WS toe. Power pole on the WS slope. Anchor on the landside (LS) slope. Rock revetment on the WS slope. (Plans for installing an irrigation pumping plant and a 20-inch discharge pipe through the levee authorized under Permit No. 1575, 1951 - Meridian Farms Water Company). [Additional Reference(s): DWR Levee Log, 2007].

View of waterward side--appurtenances present pump house, concrete distribution box, screw gate, and power pole.

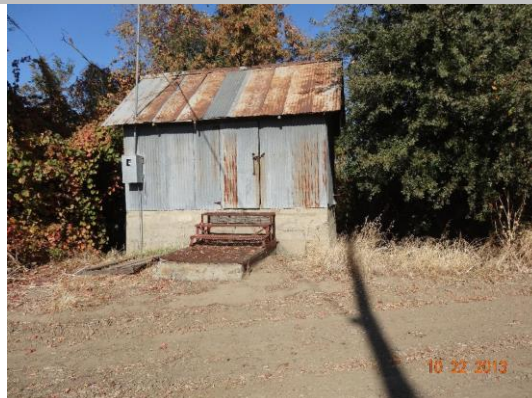
Photo 2 of 3 : UCIP_FA_2018_42923_42041.jpg

Comment Code						
Inspector Comment						
FS_ID:42923 DS_ID:21412 EP_NO: 1575 Repair Type: Non-Urgent Crossing Status: Found UCIP Comments: Debris scattered on waterward side. Concrete structure on waterward side shows major cracks on the walls. Will need to notify owner. Need to obtain maintenance records to confirm integrity of pipe. This crossing is referenced in the USACE Periodic Inspection as item USACE_CESPK_MRD2_2012_p_0075. FIELD_STRUCT_DESC: 20-inch steel irrigation discharge pipe through the levee, 17 feet below the crown. Pump and 10-inch slide gate in a pump house on the waterside (WS). Concrete collar at the WS toe. Power pole on the WS slope. Anchor on the landside (LS) slope. Rock revetment on the WS slope. (Plans for installing an irrigation pumping plant and a 20-inch discharge pipe through the levee authorized under Permit No. 1575, 1951 - Meridian Farms Water Company). [Additional Reference(s): DWR Levee Log, 2007]. FS Date: 10/23/2013

Pump station on waterward side.

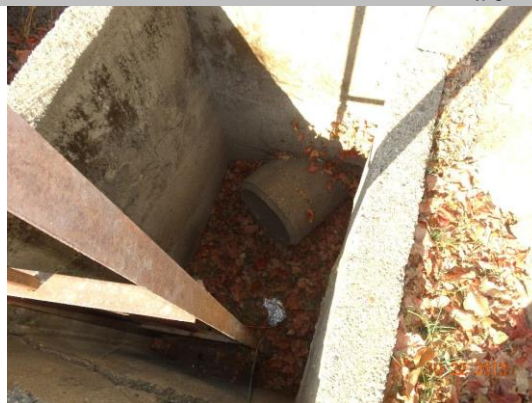
Photo 3 of 3 : UCIP_FA_2018_42923_42042.jpg

Inside view of concrete distribution box located on waterward side.

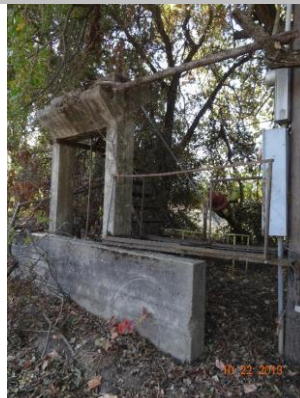
Photo 3 of 3 : UCIP_FA_2018_23885_41815.jpg

Comment Code						
Inspector Comment						
FS_ID:23885 DS_ID:21365 EP_NO: 9973 Repair Type: Non-Urgent Crossing Status: Found UCIP Comments: Cut to levee toe found on landward side. Unable to determine if crossing is being used. If crossing is no longer used by owner, the owner will need to coordinate with DWR Inspector and CVFPB to remove crossing according to Title 23 requirements. This crossing is referenced in the USACE Periodic Inspection as item USACE_CESPK_MRD2_2012_p_0099. FIELD_STRUCT_DESC: 18-inch steel irrigation discharge pipe through the levee, 18.8 feet below the crown. Slant pump on the waterside (WS). Slide gate on a gate structure on the WS. (Retention of an 18-inch steel pipe through the levee, 18.8 feet below the crown, and a slide gate authorized under Automatic Board Order (ABO) issued as Permit No. 9973, 1974 - Pearl V. Clark). [Additional Reference(s): DWR Levee Log, 2007. USACE Sacramento O&M Manual 134, June 1953, (Station 399+34)]. FS Date: 10/22/2013

Concrete structure located on waterward side with screw gate.

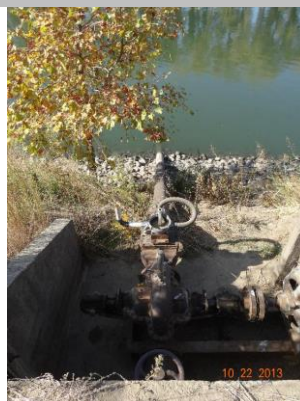
Photo 3 of 3 : UCIP_FA_2018_23888_41821.jpg

Comment Code						
Inspector Comment						
FS_ID:23888 DS_ID:21366 EP_NO: 9996 Repair Type: Non-Urgent Crossing Status: Found UCIP Comments: Need inside photo of the concrete distribution box located at the landward toe. Debris found on waterward slope (conduit running parallel to levee). This crossing is referenced in the USACE Periodic Inspection as item USACE_CESPK_MRD2_2012_p_0124. FIELD_STRUCT_DESC: 12-inch steel irrigation discharge pipe through the levee, 24 feet below the crown. Gate valve in a concrete U-shaped headwall on the waterside (WS) slope. Pump and switch house on the WS shoulder. Discharge box at the landside (LS) toe. (Retention of a 12-inch steel pipe through the levee, 24 feet below the crown, a pump, a gate valve, a switch house, and a discharge box authorized under Automatic Board Order (ABO) issued as Permit No. 9996, 1974 - Chas. F. and Nora M. Reische, et al.). [Additional Reference(s): DWR Levee Log, 2007]. FS Date: 10/22/2013

View of U-concrete headwall with positive closure device, photo 1 of 2.

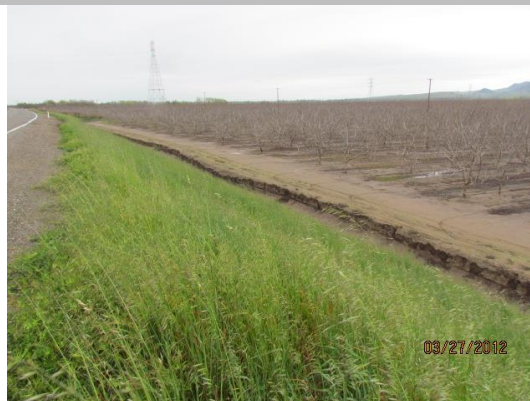
Photo 1 of 1 : FA_2018_RD0070_30_1_20180905_00001.jpg

LM Start	2.16	Rating **	M	Issue No.	1
LM End	2.32	Issue Type +	En	Location *	LS
Category	Earthen Levee			GPS Latitude/Longitude	
				Start	End
Item	Encroachments			39.168854 °	39.166503 °
				-121.936223 °	-121.935547 °
DWR ID	DWR_RD0070_02_s_2012_1				
Comment Code					
DT : Ditch					
Inspector Comment

Agricultural ditch along the landside toe.

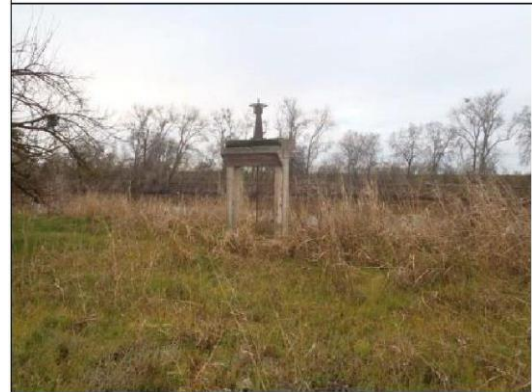
Photo 1 of 2 : UCIP_FA_2018_24115_42495.jpg

Comment Code					
Inspector Comment					
FS_ID:24115 DS_ID:21370 EP_NO: N/A Repair Type: Non-Urgent Crossing Status: Found UCIP Comments: No connection present--need to contact owner to determine if owner plans to use. If crossing is no longer in use owner will need to coordinate with DWR inspector and CVFPB to remove according to Title 23 requirements. This crossing is referenced in the USACE Periodic Inspection as USACE_CESPK_MRD2_2012_p_0197. FIELD_STRUCT_DESC: *ABANDONED* 24-inch drainage pipe of an unknown material through the levee, 18.5 feet below the crown. Slide gate on a concrete gate structure on the berm. [Additional Reference(s): DWR Levee Log, 2007]. FS Date: 10/22/2013

View of waterward side--photo is from USACE PI Report draft final issue USACE_CESPK_MRD2_2012_p_0197.

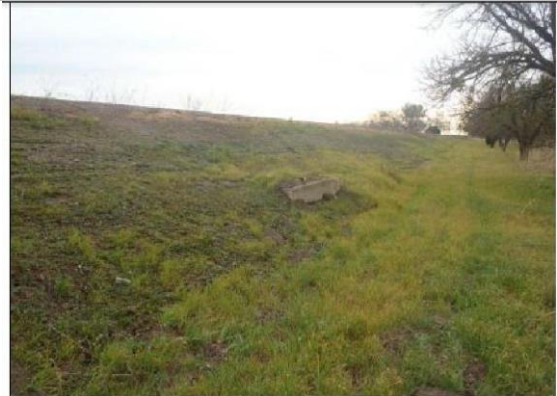
Photo 2 of 2 : UCIP_FA_2018_24115_42496.jpg

View of landward side--photo is from USACE PI Report draft final issue USACE_CESPK_MRD2_2012_p_0197.

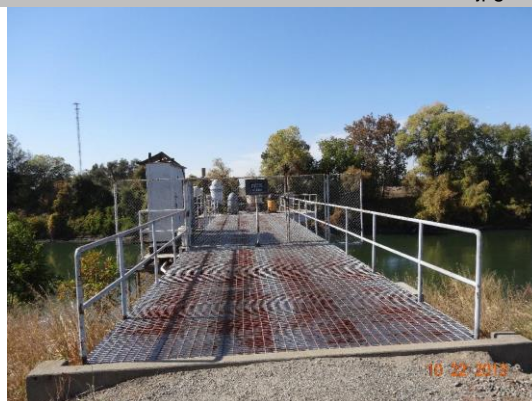
Photo 1 of 3 : UCIP_FA_2018_47030_42563.jpg

Comment Code						
Inspector Comment						
FS_ID:47030 DS_ID:21429 EP_NO: N/A Repair Type: Non-Urgent Crossing Status: Found UCIP Comments: Pump is to be demolished will all pipes removed. Will need to update record. This crossing is referenced in the USACE Periodic Inspection as item USACE_CESPK_MRD2_2012_p_0235. FIELD_STRUCT_DESC: [Meridian Farms Water Company Pumping Plant No. 1] 3 of 4: 42-inch steel irrigation discharge pipe and 2-inch polyvinyl chloride (PVC) electrical conduit through the levee, 24 and 3 feet below the crown, respectively. 42-inch pipe is concrete encased through the levee. Two concrete cutoff walls, one at each shoulder. Slide gate in a surge box on the waterside (WS). Concrete pump pit on the WS slope. Three pumps on a structure on the WS. Walkway to the pumps with an electrical control box. Concrete headwall on the landside (LS). Pipe discharges into a concrete lined irrigation ditch on the LS. Debris deflectors in the river. Power poles on the LS. (Plans to enlarge the Meridian Farms Water Company Pump Station Facility No. 1 by adding a 150-horsepower pump, a 42-inch water pipe, and a 2-inch electrical conduit through the levee authorized under Permit No. 13380, 1982 - Meridian Farms Water Company. Plans for existing pumping plant to be demolished with all pipes removed and replaced with a new Meridian Diversion pumping facility, two retractable fish screens, and a 72-inch gravity feed intake pipe under the levee authorized under Permit No. 18762, 2013 - Meridian Farms Water Company). [Additional Reference(s): DWR Levee Log, 2007]. FS Date: 10/22/2013

View of walkway and pump station on waterward side.

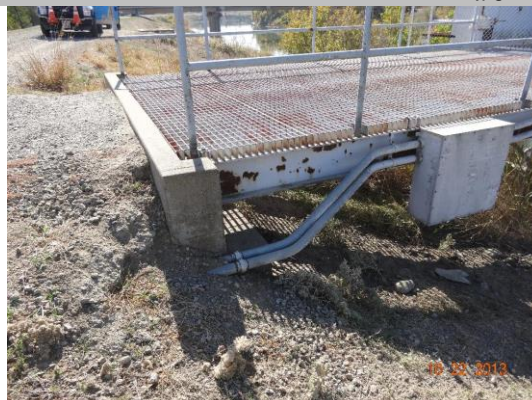
Photo 2 of 3 : UCIP_FA_2018_47032_42080.jpg

FS_ID:47032
DS_ID:21373
EP_NO: N/A
Repair Type: Non-Urgent
Crossing Status: Indicator Found
UCIP Comments: Unable to confirm 54-inch pipe only found 42-inch pipe. Pump station is to be removed. Need to update record once crossing has been modified. This crossing is referenced in the USACE Periodic Inspection as item USACE_CESPK_MRD2_2012_p_0235.
FIELD_STRUCT_DESC: [Meridian Farms Water Company Pumping Plant No. 2] 4 of 4: 54-inch steel irrigation discharge pipe through the levee, 24 feet below the crown. Pipe is concrete encased through the levee. Two concrete cutoff walls, one at each shoulder. Slide gate in a surge box on the waterside (WS). Concrete pump pit on the WS slope. Three pumps on a structure on the WS. Walkway to the pumps. Concrete headwall on the landside (LS). Pipe discharges into a concrete lined irrigation ditch on the LS. Debris deflectors in the river. (Plans for construction of a pumping plant and related facilities to replace an existing plant on the left bank of the Sacramento River authorized under Permit No. 4525, 1964 - Meridian Farms Water Company. Plans for existing pumping plant to be demolished with all pipes removed and replaced with a new Meridian Diversion pumping facility, two retractable fish screens, and a 72-inch gravity feed intake pipe under the levee authorized under Permit No. 18762, 2013 - Meridian Farms Water Company). [Additional Reference(s): DWR Levee Log, 2007].

View of conduit pipes through levee.

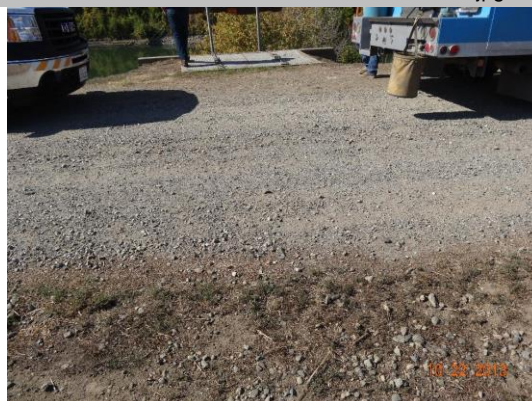
Photo 1 of 3 : UCIP_FA_2018_24165_42573.jpg

Comment Code					
Inspector Comment					
FS_ID:24165 DS_ID:21374 EP_NO: 767 Repair Type: Non-Urgent Crossing Status: Found UCIP Comments: Need to contact owner to determine if crossing is still active and to determine last inspection date. Will need copy of letter showing crossings passed inspection. This crossing is referenced in the USACE Periodic Inspection as item USACE_CESPK_MRD2_2012_p_0237. FIELD_STRUCT_DESC: 3-inch steel natural gas pipeline (not 3.5-inch, as mentioned in the desk study) through the levee, 3 feet below the crown. 8-foot by 10-foot by 1-foot concrete inspection well with a metal cover on the waterside (WS) shoulder. Rock revetment on the WS slope. Painted aluminum marker on the WS. Contact information provided on marker: (916) 742-7344 and for emergencies call (916) 742-3251. (Plans for the construction of a natural gas pipeline across the Sacramento River and the east and west levees thereof authorized under Permit No. 767, 1938 - Pacific Gas and Electric Company [PG&E]). [Additional Reference(s): DWR Levee Log, 2007]. FS Date: 10/22/2013

View of levee crown.

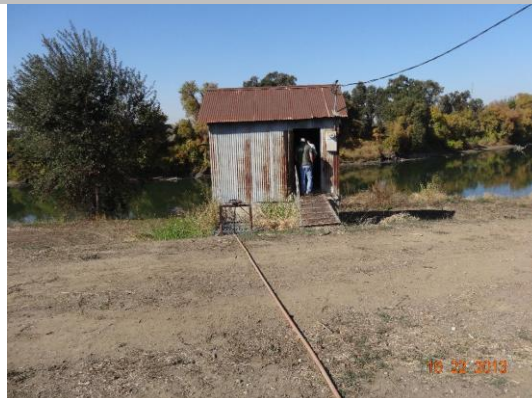
Photo 1 of 3 : UCIP_FA_2018_23962_42099.jpg

UCIP Comments: Unable to confirm if crossing corresponds to permit 9998. Pipe size is different then the pipe size listed in the desk study. Unable to confirm if structure on landward side is a pump house. Need to coordinate with owner to obtain permit record for crossing. Need to verify status of crossing. Permit authorized 24 inch pipe. Pipe through levee is 30 inches. Unable to find stand pipe in field. Dense vegetation limits the inspector's visibility to identify signs of pipe failure (leaks) along the slope. Recommend removing vegetation along pipe alignment to conduct proper inspection of structure and appurtenances. This crossing is referenced in the USACE Periodic Inspection as item USACE_CESPK_MRD2_2012_p_0264.

FIELD_STRUCT_DESC: 30-inch (not 24-inch as indicated in desk study) corrugated metal irrigation discharge pipe through the levee, 15.5 feet below the crown. Slide gate in a concrete distribution box at the landside (LS) toe. Pump in a pump house on the LS. Service pole and ramp on the waterside (WS) slope. Concrete box with air vents on the WS end. (Retention of a 24-inch corrugated metal pipe (CMP) through the levee, 15.5 feet below the crown, a pump, a slide gate, a service pole, and a concrete distribution box authorized under Automatic Board Order (ABO) issued as Permit No. 9998, 1974 - Robert Tod Ruse, Trustee. Plans to install an 18-inch polyvinyl chloride (PVC) pipe through an existing 24-inch steel pipe under the levee with annular space grouted authorized under Permit No. 16228, 1994 - Mike and Carol Churkin). [Additional Reference(s): DWR Levee Log, 2007. USACE Sacramento O&M Manual 134, June 1953, (Station 516+06)]. FS Date: 10/22/2013

View of pump house located on waterward side.

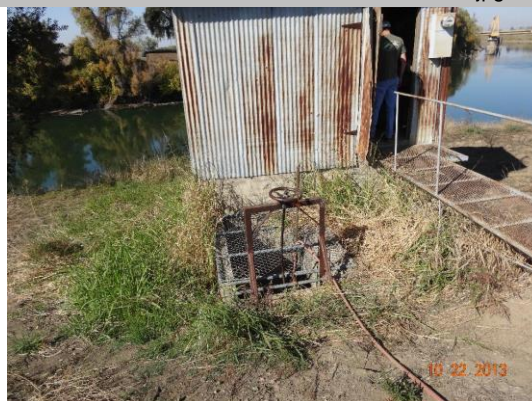
Photo 2 of 3 : UCIP_FA_2018_23962_42104.jpg

Positive closure device located at the waterward side inside concrete distribution box.

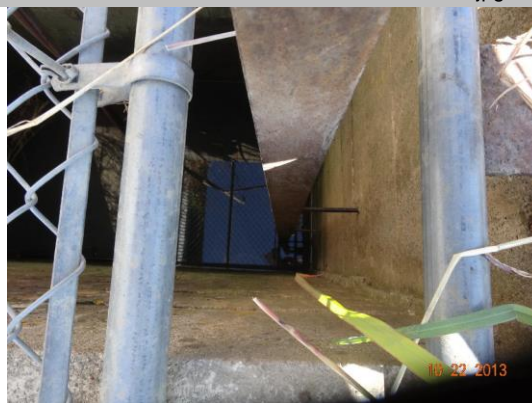
Photo 3 of 3 : UCIP_FA_2018_23962_42101.jpg

Photo of the concrete distribution box located on waterward side.

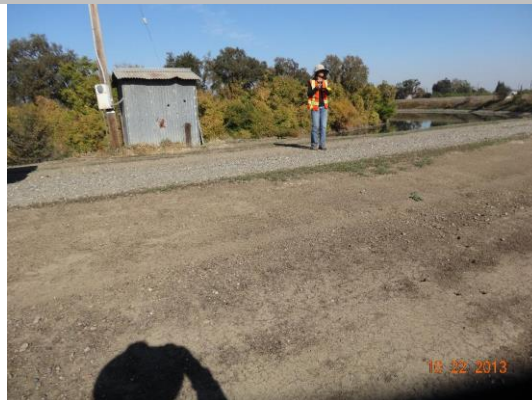
Photo 2 of 3 : UCIP_FA_2018_24166_42580.jpg

View of levee crown and pump house photo taken from landward side.

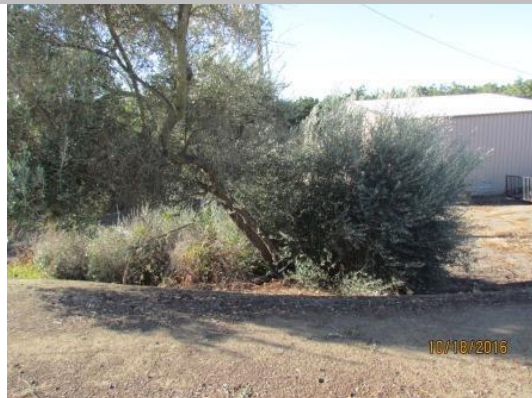
Photo 1 of 1 : FA_2018_RD0070_30_54_20180905_00008.jpg

LM Start	4.95	Rating **	M	Issue No.	54
LM End	4.95	Issue Type +	Ma	Location *	LS
Category	Earthen Levee			GPS Latitude/Longitude	
				Start	End
Item	Trim / Thin Trees			39.142016 °	39.142016 °
				-121.926214 °	-121.926214 °
DWR ID	DWR_RD0070_02_f_2016_54				
Comment Code					
T1 : Trim trees to at least five feet above ground level.					
Inspector Comment

View of the trees blocking visibility.

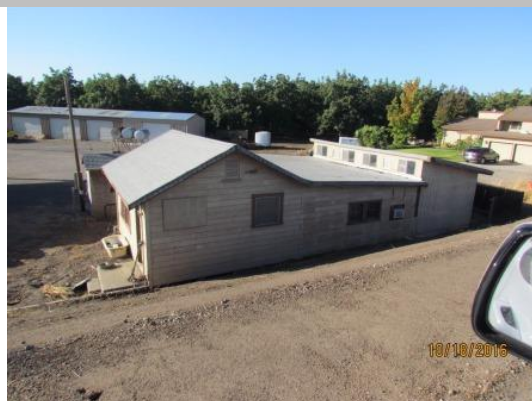
Photo 1 of 1 : FA_2018_RD0070_30_9_20180905_00003.jpg

LM Start	4.95	Rating **	U	Issue No.	9
LM End	4.98	Issue Type +	En	Location *	LS
Category	Earthen Levee			GPS Latitude/Longitude	
				Start	End
Item	Encroachments			39.142008 °	39.142032 °
				-121.926267 °	-121.926855 °
DWR ID	DWR_RD0070_02_s_2012_9				
Comment Code					
BU : Building					
Inspector Comment

View of a building within the easement of the levee.

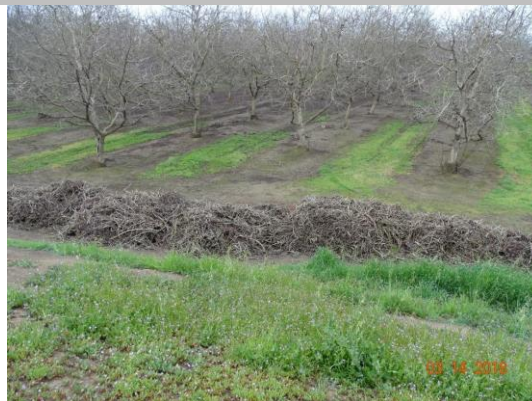
Photo 1 of 1 : FA_2018_RD0070_30_47_20180905_00004.jpg

LM Start	5.08	Rating **	M	Issue No.	47
LM End	5.08	Issue Type +	En	Location *	LS
Category	Earthen Levee			GPS Latitude/Longitude	
				Start	End
Item	Encroachments			39.141938 °	39.141938 °
				-121.928597 °	-121.928597 °
DWR ID	DWR_RD0070_02_s_2018_47				
Comment Code					
PR : Prunings					
Inspector Comment					
Remove the prunings from the landside toe.

View of the prunings along the landside toe.

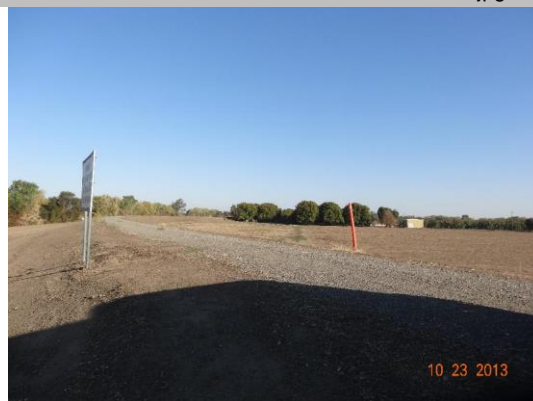
Photo 1 of 3 : UCIP_FA_2018_23965_42123.jpg

Comment Code					
Inspector Comment					
FS_ID:23965 DS_ID:21385 EP_NO: 4383 Repair Type: Non-Urgent Crossing Status: Found UCIP Comments: Need to contact owner to determine if crossing is still active and to determine last inspection date. Will need copy of letter showing crossings passed inspection. This crossing is referenced in the USACE Periodic Inspection as item USACE_CESPK_MRD2_2012_p_0319. FIELD_STRUCT_DESC: 8.625-inch steel natural gas pipeline through the levee, 3.5 feet below the crown. Concrete cutoff wall around the pipe at the center of the levee. Rock revetment on the waterside (WS) slope. (Plans for construction, maintenance, and use of an 8.625-inch gas line authorized under Permit No. 4383, 1963 - Pacific Gas and Electric Company [PG&E]). [Additional Reference(s): DWR Levee Log, 2007]. FS Date: 10/23/2013

Markers visible on both levee shoulders.

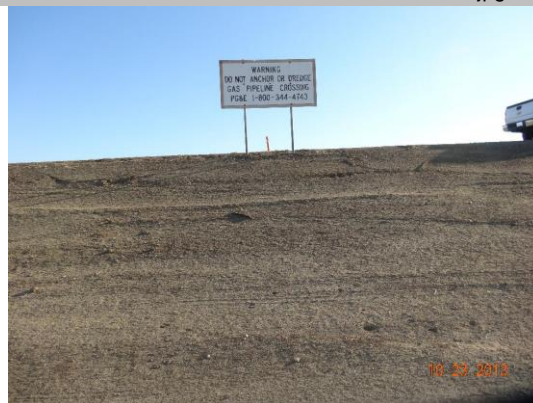
Photo 2 of 3 : UCIP_FA_2018_23965_42121.jpg

View of waterward slope.

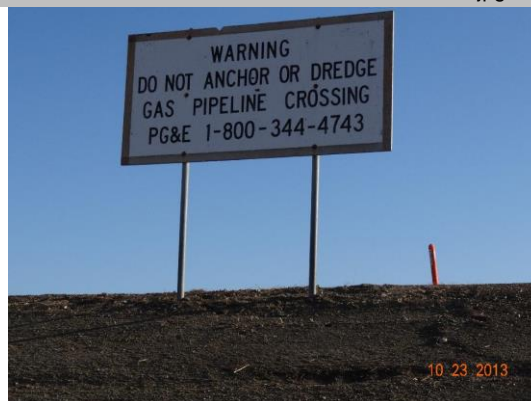
Photo 3 of 3 : UCIP_FA_2018_23965_42122.jpg

Sign visible on waterward side.

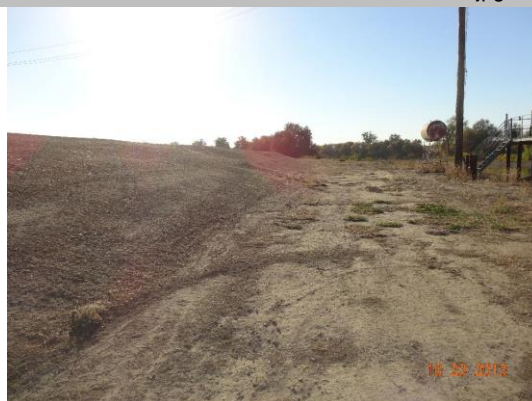
Photo 1 of 3 : UCIP_FA_2018_46424_42043.jpg

FS_ID:46424
DS_ID:21386
EP_NO: 9994
Repair Type: Non-Urgent
Crossing Status: Found
UCIP Comments: 07/28/2015 System was running during site visit. Damage to landward side has been repaired. No records available to determine cause of erosion--monitor. No other issues observed during site visit. 10/23/2013 Erosion visible on landward side behind concrete headwall. Plastic sheeting has been placed to protect slope. Need to determine cause for erosion, is pipe leaking? Pipe wall on landward side has deteriorated significantly that the wall is gone. Owner will need to coordinate with DWR inspector and CVFPB to address issue. Recommend notifying owner to stop using crossing until issue has been addressed. This crossing is referenced in the USACE Periodic Inspection as item USACE_CESPK_MRD2_2012_p_0324.
FIELD_STRUCT_DESC: 20-inch coated steel irrigation discharge pipe on the waterside (WS) and 24-inch coated steel irrigation discharge pipe on the landside (LS) through the levee, 12.5 feet below the crown. Pipe is concrete encased under the crown, between the shoulders. Slide gate in a metal well on the WS slope. Pump on a pile structure in the stream. Concrete discharge box at the LS toe. Service pole on the WS slope. (Plans for the installation of an irrigation pumping plant and appurtenant electrical power line across the levee authorized under Permit No. 1202, 19 - Hannah R. Jacobs. Retention of a 24-inch concrete encased steel pipe through the levee, 12.5 feet below the crown, a pump, a slide gate, and a concrete discharge box authorized under Automatic Board Order (ABO) issued as Permit No. 9994, 1974 - R. X. Ranch Company). [Additional Reference(s): DWR Levee Log, 2007. USACE Sacramento O&M Manual 134, June 1953, (Station 610+84)].

View of levee slope and berm on waterward side.

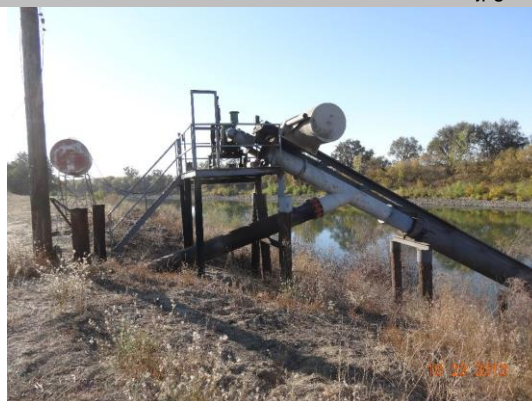
Photo 2 of 3 : UCIP_FA_2018_46424_42049.jpg

Pipe and pump set up on waterward side.

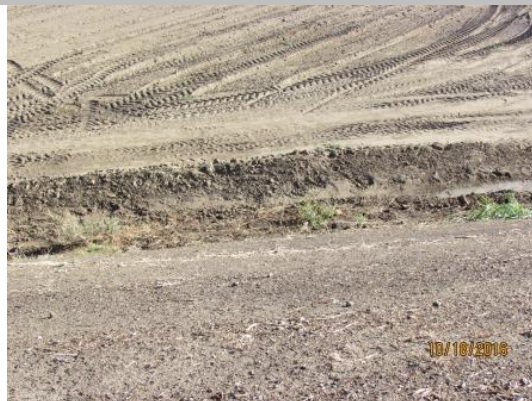
Photo 1 of 1 : FA_2018_RD0070_30_57_20180905_00010.jpg

LM Start	7.18	Rating **	M	Issue No.	57
LM End	7.18	Issue Type +	En	Location *	LS
Category	Earthen Levee			GPS Latitude/Longitude	
				Start	End
Item	Encroachments			39.128114 °	39.128114 °
				-121.923429 °	-121.923429 °
DWR ID	DWR_RD0070_02_f_2016_57				
Comment Code					
DT : Ditch					
Inspector Comment

View of a ditch along the landside toe.

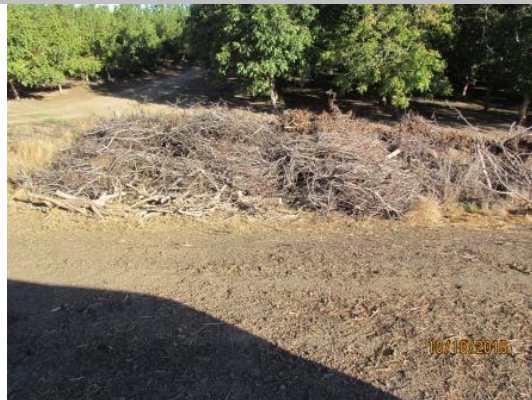
Photo 1 of 1 : FA_2018_RD0070_30_58_20180905_00011.jpg

LM Start	7.62	Rating **	U	Issue No.	58
LM End	7.64	Issue Type +	En	Location *	LS
Category	Earthen Levee			GPS Latitude/Longitude	
				Start	End
Item	Encroachments			39.124448 °	39.124493 °
				-121.917505 °	-121.917090 °
DWR ID	DWR_RD0070_02_f_2016_58				
Comment Code					
PR : Prunings					
Inspector Comment					
Remove prunings from the landside toe.

View of the prunings along the landside toe.

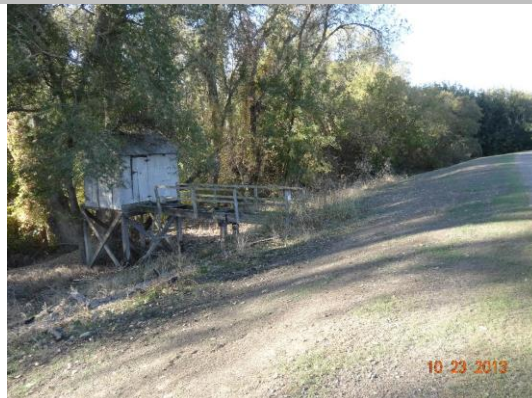
Photo 1 of 3 : UCIP_FA_2018_23966_42128.jpg

Pump house located on waterward side.

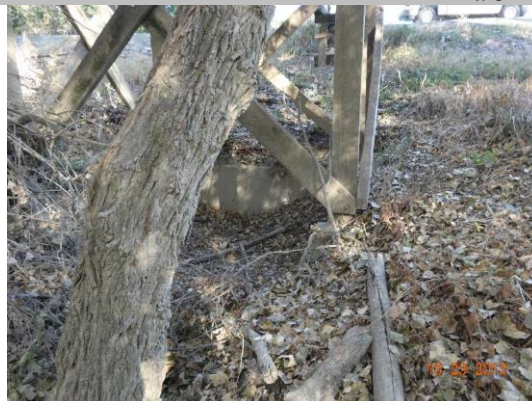
Photo 2 of 3 : UCIP_FA_2018_23966_42126.jpg

Concrete headwall located on waterward side.

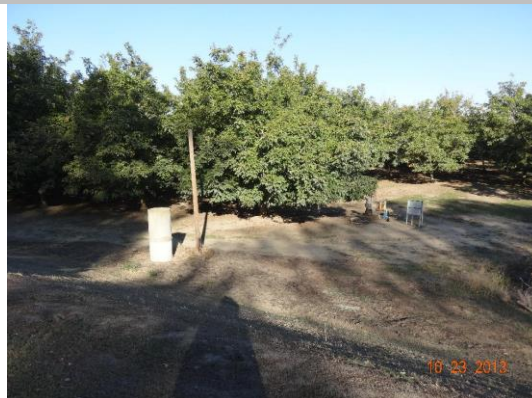
Photo 3 of 3 : UCIP_FA_2018_23966_42127.jpg

Comment Code						
Inspector Comment						
FS_ID:23966 DS_ID:21387 EP_NO: 9966 Repair Type: Non-Urgent Crossing Status: Indicator Found UCIP Comments: Pipe daylight at waterward side blocked. Unable to determine if connection is present--need to contact owner to determine if owner plans to use. If crossing is no longer in use owner will need to coordinate with DWR inspector and CVFPB to remove according to Title 23 requirements. Unable to determine if crossing is in use. This crossing is referenced in the USACE Periodic Inspection as item USACE_CESPK_MRD2_2012_p_0371. FIELD_STRUCT_DESC: 10-inch coated steel irrigation discharge pipe and 1.5-inch electrical conduit of an unknown material through the levee, 12 feet and 8 feet below the crown, respectively. Pipe is concrete encased under the crown, between the shoulders. Concrete cutoff wall under each shoulder. Pump and gate valve on a pile structure in the stream. Walkway to the pump. Concrete standpipe on the landside (LS). (Retention of a 24-inch corrugated metal drainage pipe through the levee, 13 feet below the crown, a flap gate, and two concrete headwalls authorized under Automatic Board Order (ABO) issued as Permit No. 11496, 1976 - Earl Foutch). [Additional Reference(s): DWR Levee Log, 2007. USACE Sacramento O&M Manual 134, June 1953, (Station 689+50)]. FS Date: 10/23/2013

Stand pipe located on landward side.

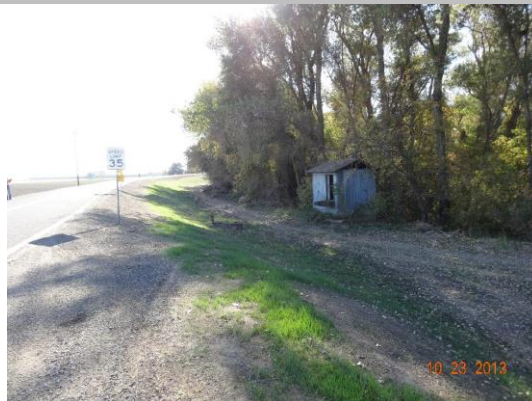
Photo 2 of 3 : UCIP_FA_2018_24191_42678.jpg

View of waterward side--only pump house of nearby crossing located downstream from crossing.

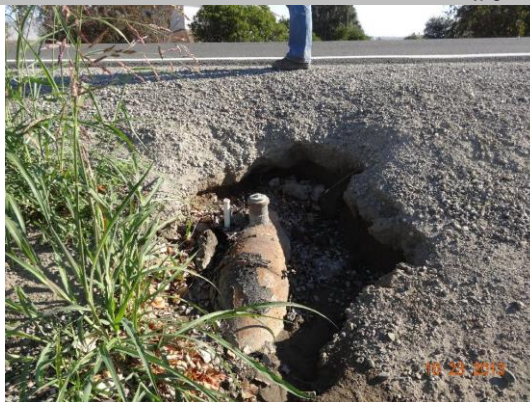
Photo 2 of 3 : UCIP_FA_2018_50007_42680.jpg

FS_ID:50007
DS_ID:21390
EP_NO: 10371
Repair Type: Non-Urgent
Crossing Status: Found
UCIP Comments: 7/07/2016 Crossing was downgraded from Urgent to Non-Urgent -- siphon breaker leak was repaired back in September 2015. Still need to coordinate with owner for additional details regarding pipe (install date, owner confirmation, and crossing size change from 15-inch to 12-inch). Also dense vegetation visible along pipe on both WS and LS slopes. (DWR UCIP - omagana)9/15/2015 Leak was caused by leaky siphon breaker. Siphon breaker was repaired and a protective encasing around the siphon breaker was installed. Levee was repaired. Need to contact owner to determine additional information regarding the pipe. (DWR UCIP - omagana)7/28/2015 Hole present on waterward slope has gotten worse since last inspection. The hole is located less than 2 feet from S Meridian Road (county road). Dense vegetation on waterward slope limits visual inspection to determine extent of levee damage or cause. According to LMA representative the damage on the slope was caused by leaky siphon breaker. LMA representative has notified owner to stop use of pipe. Based on the extent of the damage visible from prior inspection and the age of the pipe, this pipe would be a good candidate for video or pressure test to confirm the integrity of pipe through levee (county road). Owner will need to coordinate with DWR Inspector and CVFPB to address leaky pipe per Title 23 requirements. (DWR UCIP - omagana)10/23/2013 Pipe leaking on waterward side. Recommend LMA superintendent notify owner to stop using crossing to avoid further damage to levee slope. Owner will need to coordinate with DWR Inspector and CVFPB to address leaky pipe per Title 23 requirements. Also recommend having owner clear out some of the vegetation along the pipe alignment (below pump station) to conduct proper inspection of structure and appurtenances. This crossing is referenced in the USACE Periodic Inspection as item USACE_CESPK_MRD2_2012_p_0391. (DWR UCIP - omagana)

Damage to WS shoulder due to leaky pipe or siphon breaker.
